# FIRE RISK ASSESSMENT REPORT

**CLIENT: Tamworth Borough Council**

**SITE: Stanhope House**

**SURVEY DATE: 5th July 2017**

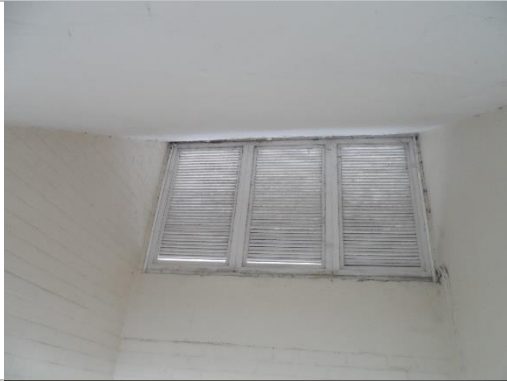
General Observations & Photographic Evidence		
<p><b>Photo No 1</b>  <b>Reference point : D32</b>  <b>Location:</b> Staircase  <b>Comments:</b>            At the head of the staircase there is a permanent louvered vent which may have mechanical extraction</p>

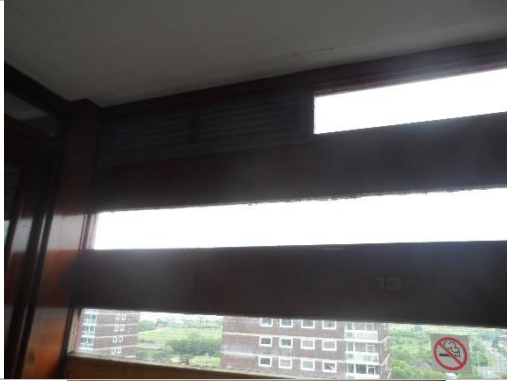
<p><b>Photo No 2</b>  <b>Reference point : D32</b>  <b>Location:</b> Staircase  <b>Comments:</b>            At each third level in the staircase there are small vents to the glazed screen</p>

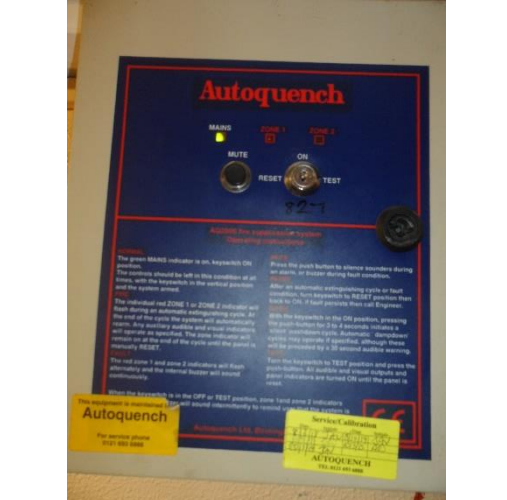
<p><b>Photo No 3</b>  <b>Reference point: F16</b>  <b>Location:</b> Ground floor  <b>Comments:</b>            In the bin store there is an 'Autoquench' system installed using AQ2000 (water mist). There is a control panel in the lift lobby at ground floor.</p>

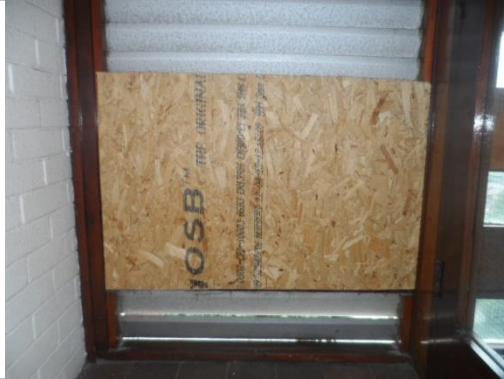
**Photo No 4**  
**Action point: D36a**  
**Location: 14<sup>th</sup> floor**  
**Comments:**  
There is an area of louvered vent in the 14<sup>th</sup> floor bin chute lobby that has been boarded over.

D36	Are there in built means of ventilating escape routes?	Y	In the lobby between the staircase and the lift lobby there is a louvered vent.  At each third level in the staircase there are small vents to the glazed screen.  At the head of the staircase there is a permanent louvered vent.		
D36a	Are the areas of ventilation in good condition?	N	2	2	2

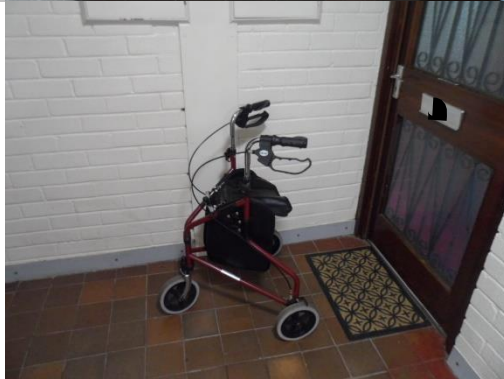
**Photo No 5**  
**Action point: D6**  
**Location: 10<sup>th</sup> floor**  
**Comments:**  
There was a walker stored outside of number

Hazard Ref No	Location	Hazard Description	Priority	Recommended Action	Action by date	Status	Comment
A17	Management	There no available records on site to indicate that the fixed electrical installation has been subject to a full 5 yearly test by a competent engineer.	Low	It should be ensured that the fixed electrical installation is subject to an appropriate testing and maintenance regime.	October 2017		The date on the main panel for fixed wiring test was 26 <sup>th</sup> January 2011
A24	Throughout	Mains electrics cables located in common escape routes should be secured to the structure using fixings that in the event of fire will not fail.  This ensures live cables are not hanging down creating a hazard during fire fighting	Low	During refurbishment or when mains electrics are being worked on the fixings should be changed.	As work is ordered to electrics systems		
D6	10 <sup>th</sup> floor	To ensure that they can be safely used, fire escape routes must be kept clear of obstructions and the storage of combustible items.	Low	The following fire exit routes were obstructed and require clearing:  1: There was a walker stored outside of number .  (Photo 5)	October 2017

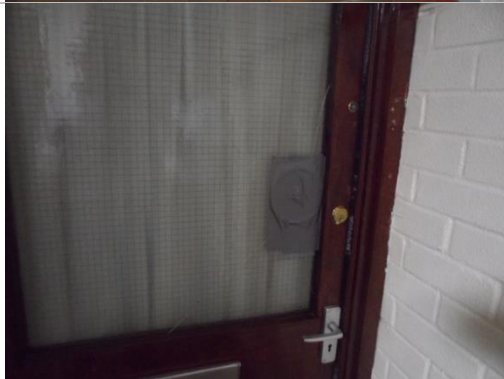
**Photo No 6**  
**Action point: D33**  
**Location: 8<sup>th</sup> floor**  
**Comments:**  
8<sup>th</sup> floor – The door to flat has cracked glazing that needs replacing.

Hazard Ref No	Location	Hazard Description	Priority	Recommended Action	Action by date	Status	Comment
D33	8 <sup>th</sup> floor	Glazing installed in fire doors and partitions should achieve at least the same level of fire resistance as the door or partition in which it is sited.	Medium	<p>Glazing within the following fire doors/partitions are damaged or do not appear to be fire resisting:</p> <p>1: 8<sup>th</sup> floor – The door to flat has cracked glazing that needs replacing. (Photo 6)</p> <p>2: 4<sup>th</sup> floor - the door from the staircase to the bin chute lobby has cracked glazing that needs replacing.</p> <p>3: 1<sup>st</sup> floor - the door from the staircase to the bin chute lobby has cracked glazing that needs replacing.</p>	October 2017
