**CONSERVATION AREA
CHARACTER APPRAISAL**

WILNECOTE

**TAMWORTH BOROUGH
COUNCIL**

Date: March 2008

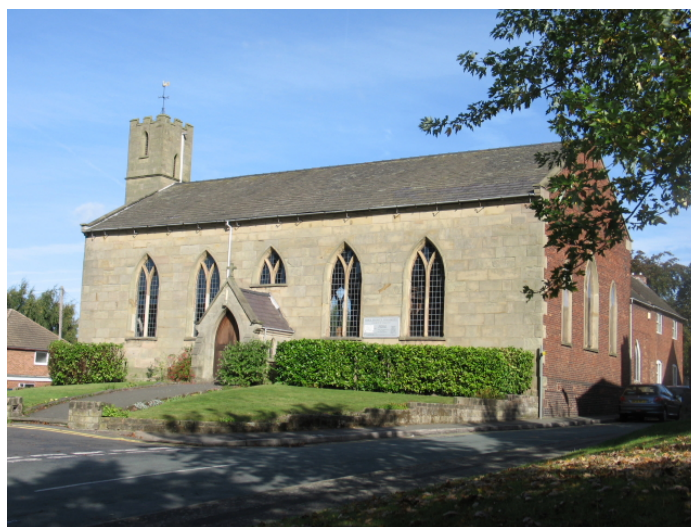
- 5.1.7 The most impressive and visually dominating building in this character area is Holy Trinity Parish Church. The church was built in 1821 in the Gothic Revival style, of brick with ashlar dressings (although its south and west elevations are completely faced with ashlar, making it appear stone-built from the south). It is architecturally rather spare, making the five pointed-arch windows with Y-tracery on its south elevation quite striking. The church is listed at Grade II and is the only listed building in this character zone.

Holy Trinity Church

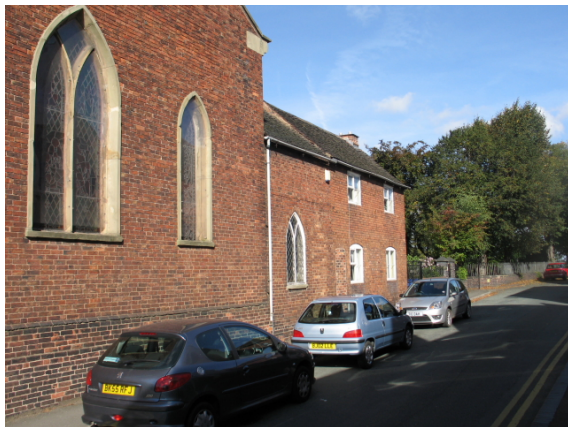
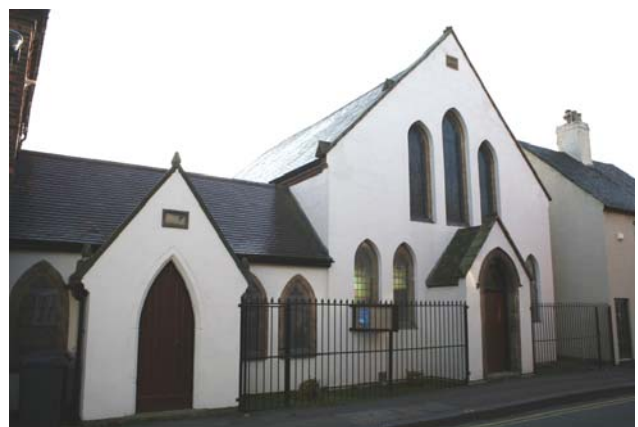
5.1.8 The east elevation of the church and the adjoining mid 19th-century vestry and former vergers' house are of red brick and front directly onto the pavement to Glascote Lane and, despite various blocked openings, make an attractive group. Facing them is the Wilnecote Congregational Chapel, an attractive Gothic Revival building (but of the Victorian Gothic style rather than the late Georgian of Holy Trinity) faced with white-painted ashlar. It bears a date-stone of 1892, although the single-storey range to the north appears to have been added between 1924 and 1939 (its date-stone is now illegible). The chapel's stone-coped gable end with kneelers complements the gable end of the church opposite, and both together make an attractive frame to the view along Glascote Lane from the south. The chapel should be considered for addition to the local list.

Vestry and former Verger's house, Holy Trinity (left), Congregational Chapel (right)

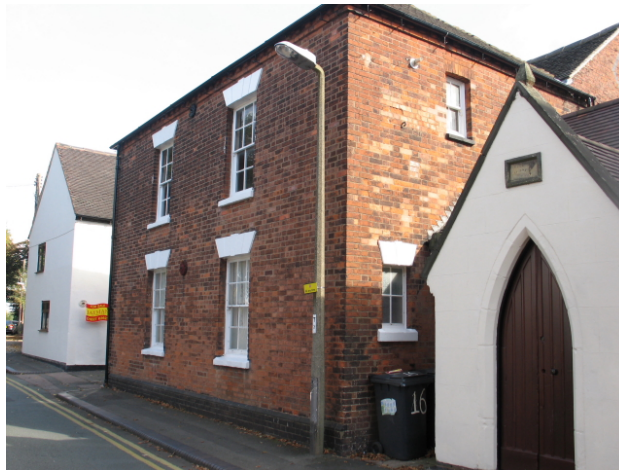
5.1.9 Flanking the chapel are two houses; No. 18 to the north is marked as a 'hall' on the modern-day maps, and is joined to the chapel by the latter's extension. It is an attractive two-storey red brick building with a hipped roof, sash windows and splayed white-painted window heads with keystones. To the south No. 16, with its white-painted render and steeply-pitched roof, is of similar appearance to No. 20 adjoining the red brick No. 18. Despite replacement window frames to Nos. 16 and 20, the group of four buildings has an attractive appearance.

The attractive No. 18 Glascote Lane

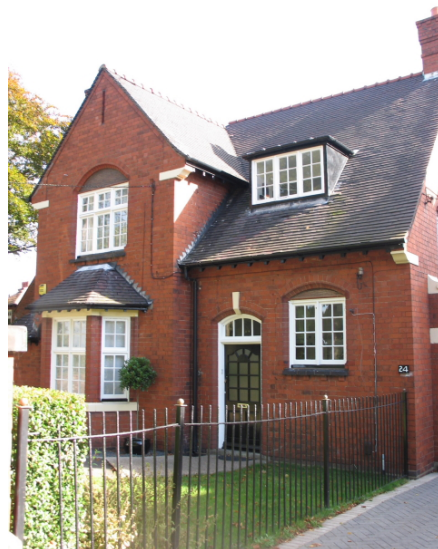
5.1.10 North of these is a row of relatively large, early 20th-century detached red brick houses. Nos. 22-24 (No. 22 being the former police station and No. 24 possibly housing the station's head police officer) were built in 1913, as the surviving station date-stone reveals. They are large buildings in a mildly Arts and Crafts-influenced style with attractive windows and gables to the street, set back behind front gardens separated from the lane by railings and original brick gate piers capped with stone ball finials.

No. 24 Glascote Lane

5.1.14 It may be considered appropriate to place an Article 4 direction on Nos. 22-24 and 30, in order to ensure the continued high level of survival of original windows and doors.

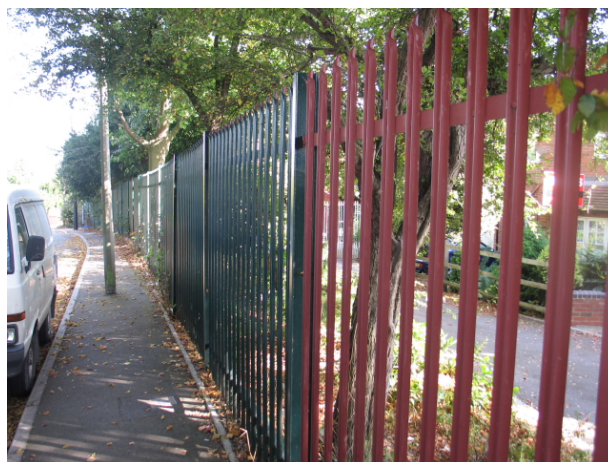
5.1.13 Nos. 26-30 Glascote Lane are set well back behind the street frontage on a separate branch off the lane, divided from it by rather unfortunate steel railings and a line of trees and shrubbery. No. 30, the Vicarage, was probably built in the mid to late 1920s and is a large and attractive red brick house with an asymmetrical Arts and Craft influenced appearance. The plot in which it sits has been truncated to make way for Nos. 26 and 28, built in the 1990s. Both have been very sympathetically designed to fit in with the architectural style of the lane and do not appear out of place.

Inappropriate steel railings in front of Nos. 26-30 Glascote Lane

- 5.1.22 General room for improvement is available with regard to street furniture and paving, as outlined above. Traditional style paving would be of benefit around the church and along Glascote Lane and the replacement with something more appropriate of the steel railings in front of Nos. 26-30 would be of clear benefit.

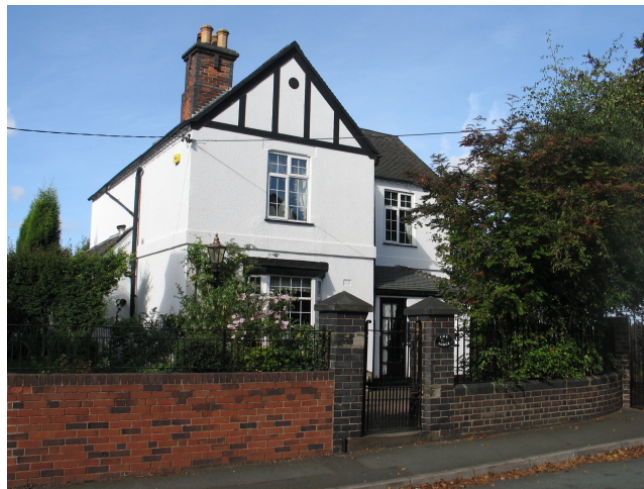
- 5.1.15 On the west side of Glascote Lane, just beyond the church offices and between them and the cemetery is The Lodge, a large late 19th-century house set back from the street behind a garden and curved (mostly rebuilt) brick wall with iron railings. It is now covered with white-painted render but appears to be of brick with stone dressings and has applied timber framing to the front gable. Its windows are unfortunately uPVC replacements, but the house makes its own contribution to the eclectic architectural styles present on the lane.

The Lodge

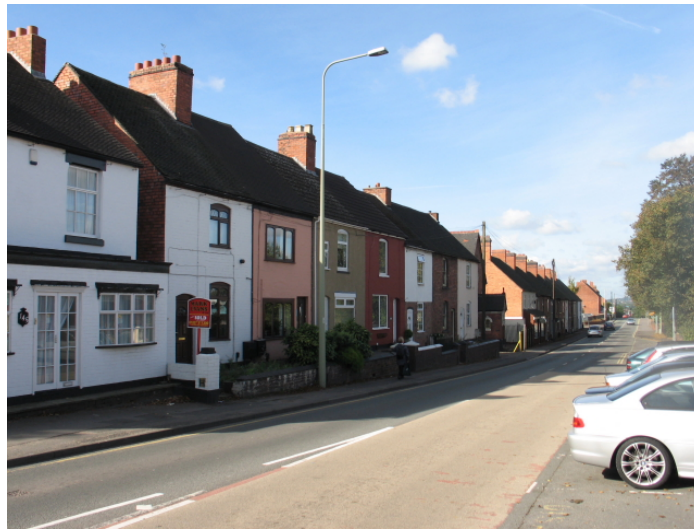
- 5.2.4 Nos. 147-159 Watling Street comprises a row of small, Victorian plain red brick terraced houses, some rendered. These, with the single exception of No. 157, which retains original window openings and sashes, have been subject to wholesale reconfiguration and replacement of the openings on their front elevations. This has given the terrace an incoherent appearance and it has lost its historic architectural character. The houses have small front yards and are bordered by an original low, stone-capped brick wall incorporating original gate piers.

Terraced Houses on Watling Street have undergone unfortunate alterations

- 5.2.5 The general incoherent appearance created by individual owners altering their properties in differing ways, is sometimes referred to as 'pepper-potting', and is only exacerbated by No. 45 which, presumably once two separate dwellings is now a single house with a large porch extension across the whole of its frontage.

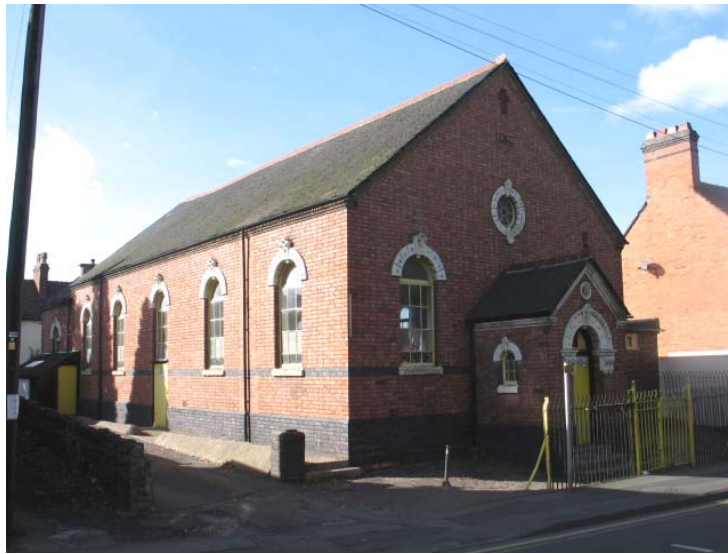
- 5.2.6 Sandwiched between this terrace and its continuation with Nos. 163-189 (outside the conservation area) is the former Holy Trinity Sunday School, most recently used by a scout group and currently awaiting a new use. This is a simple but attractive building, gabled to the street, of red brick with blue brick sill band and plinth and a pitched clay tile roof. The building has some attractive architectural features, including round-arched windows and door with elaborate decorative stone window heads. The original multi-paned windows are intact, each containing a row of stained-glass panes, with a row of frosted panes above. The street elevation has a lunette with 1894 date-stone above, and below a gabled porch built to resemble a stone pediment with decorative cornice. A roundel above the keystone contains a sculpted wreathed female head. The decorative work is of a high standard and the building makes an important contribution to the street and to the conservation area; it should certainly be considered for addition to the local list.

Holy Trinity Sunday School, recommended for inclusion on the local list

- The former Holy Trinity Sunday School, Watling Street

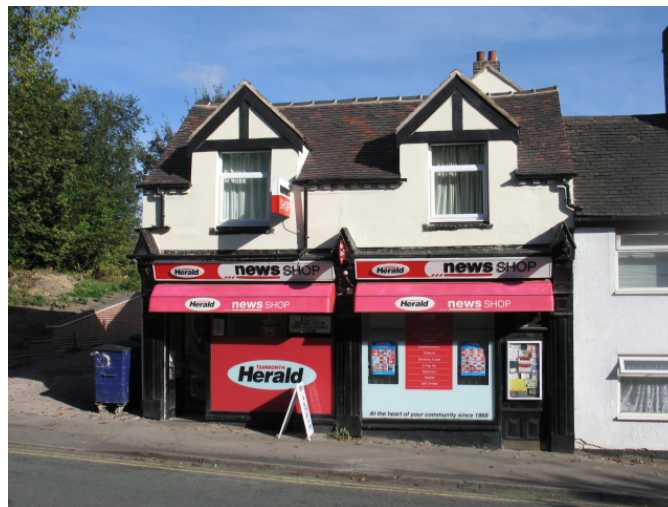
5.2.10 A similar degree of alteration to front elevations has occurred on the other side of the conservation area on the north side of Watling Street. The short terrace containing Nos. 36-42 has an odd appearance as a group. No. 42, probably originally two dwellings, is now a single shop, with surviving late 19th-/early 20th-century shop fronts visible behind the loud modern signage. Its two mock-timber framed dormers rising through the eaves make an odd contrast with the wholesale replacement in uPVC (and reconfiguration) of the windows to the adjoining white-rendered Nos. 38-40, also originally two houses and now altered to form one.

No. 42 Watling Street

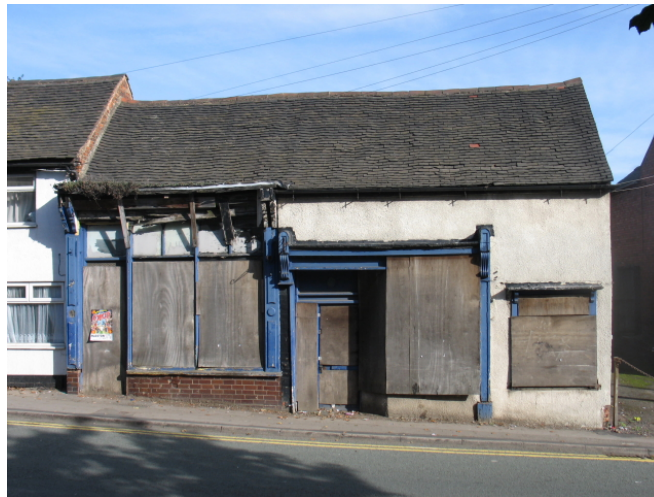
5.2.10 No. 36, however, is in a sorry state and its condition needs to be addressed. The building appears from the front to be of a single storey with two surviving late 19th-/early 20th-century shop fronts and what is probably an old shop window (all now boarded up), although the side elevation shows a blocked door opening and window above. The building has been extended to the rear on a number of occasions, with a small complex of workshops, all now boarded up. The group provides an interesting glimpse into the 20th-century commercial history of this part of Watling Street but in its current condition is creating an eyesore.

No. 36 Watling Street, in need of renovation

5.2.19 The poor state of repair and dereliction of No. 36 Watling Street is currently having a negative impact on the character and appearance of the conservation area, and this situation will only worsen as the building continues to deteriorate.

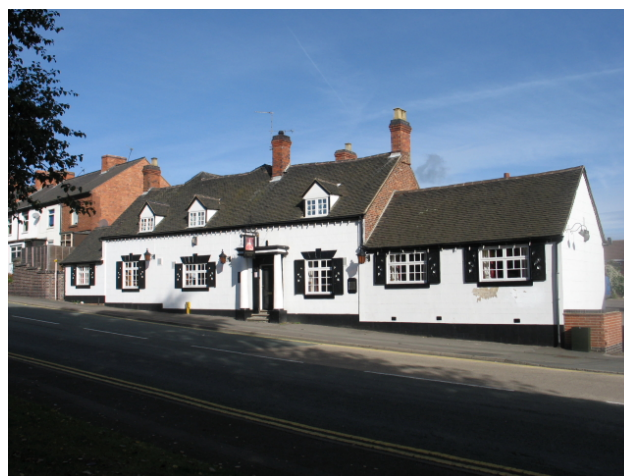
5.2.12 East of No. 20, the Queen's Head public house is the only listed building in this character zone, listed at Grade II in 1972. It dates to the 17th century with later additions, but may have even earlier origins as a cruck-framed building. It is of a single storey with dormer windows in the attic and has a long, rambling frontage. Its white-painted stucco front and multi-paned casements cause it to stand out in the streetscape.

Grade II Listed Queen's Head

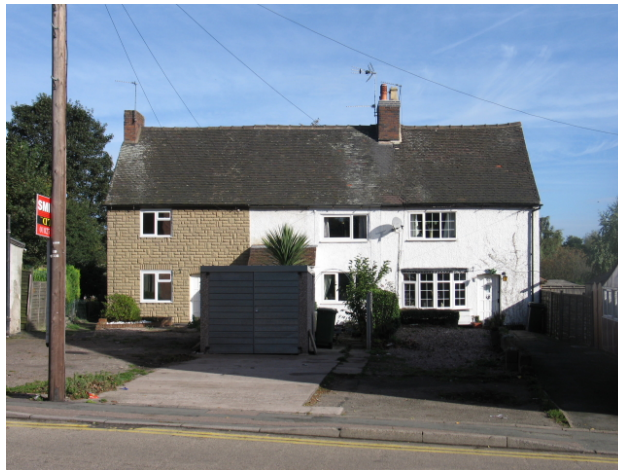
5.2.13 The street frontage east of the Queen's Head is rather fragmented, with the short terrace containing Nos. 12-16 standing directly on the pavement. The front elevations have been altered. Nos. 2-4 have been subject to similar alteration, No. 2 having a modern shop front. Between these two short stretches of terrace are Nos. 6-10, three terraced cottages, probably older than those on the street frontage, and set very well back from the street. Historically, the cottages shared a large rectangular yard to the front and it's possible that they may once have had some connection with Wilnecote Hall to the east. Today, this yard is divided into three driveways (although not physically separated) and a garage has been built in front of No. 8. Again, the front elevations have been altered.

Nos. 6-10 Watling Street

- 5.2.21 The patchy and shabby driveways in front of Nos. 6-10 also have a negative impact on the area's character and appearance, as does the utilitarian garage erected in front of No. 8, which obscures the view of the cottages (themselves now altered).
- 5.2.22 The utilitarian steel railings along the south side of Watling Street in front of the Globe Inn, although outside the conservation area, have a negative impact upon it and serve to emphasise the dislocation of one side of the street from the other. These could be replaced by railings of better quality. In more general terms, the quality of the street lighting furniture could also be improved upon.
- 5.2.23 The close boarded fencing delineating the boundary between Wilnecote Hall and Orkney Drive is not an ideal boundary treatment for this building, and detracts from its historic character and appearance.

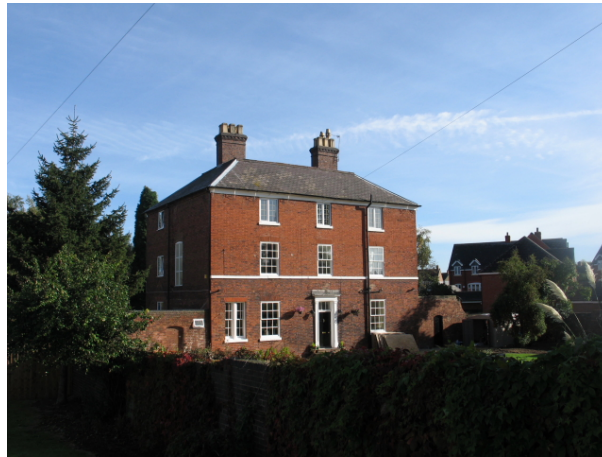
5.2.15 Wilnecote Hall is a pleasant-looking if architecturally unremarkable 18th-century house, and is included on the local list. It is of three storeys, built in red brick with a hipped tile roof and two prominent chimney stacks. It sits within a large garden, well back from the street frontage and well-concealed from it by a high brick wall and

trees. The elevation to the street could well have historically been its rear elevation, as the 1884 O.S. map shows its carriage driveway approaching the north elevation, and a large glass-roofed structure (a winter garden or conservatory) attached to (and even wider than) the south elevation at this time. The building is of much greater scale than anything else of pre 20th-century date (besides the church) in Wilnecote, and has important historical associations with the settlement's 18th-century history.

Wilnecote Hall

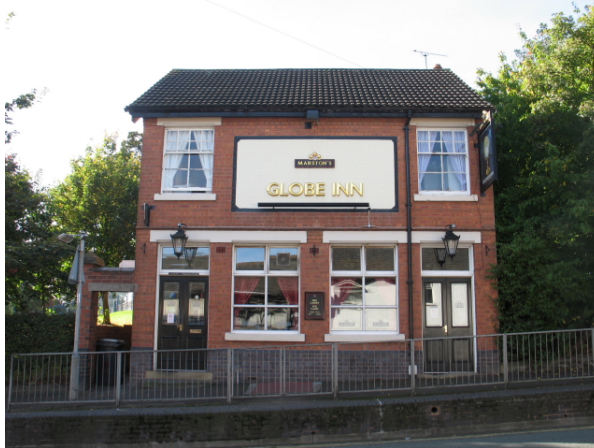
5.2.17 On the south side of Watling Street, opposite No. 36, is the Globe Inn, probably historically two separate dwelling houses – it is not marked as an inn on the historical maps. This is an attractive building with surviving upper-floor sashes, its appearance slightly marred by the inappropriate and heavy-looking concrete tile roof. It is the lone survivor of the clearance of this side of the street in the second half of the 20th century

and should be considered for addition to the local list and inclusion within the designated area.

The Globe Inn, recommended for addition to the local list and inclusion within the conservation area

6.1 Two relatively minor changes are proposed to the conservation area boundary. The first is to extend the boundary south to include the Globe Inn. The second minor change is to redraw the boundary at the western end of the conservation area to exclude No. 161 Watling Street.

- The Globe Inn
