FIRE RISK ASSESSMENT REPORT

CLIENT: Tamworth Borough Council

SITE: Weymouth House

SURVEY DATE: 5th July 2017

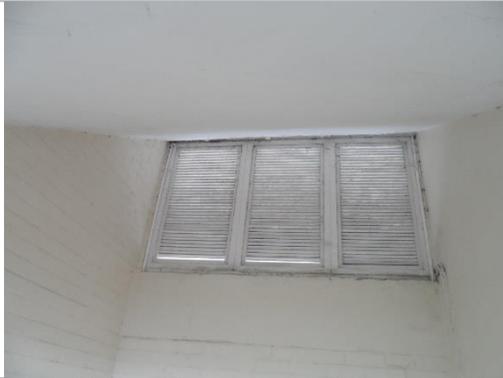
General Observations & Photographic Evidence		
<p>Photo No 1 Reference point : D32 Location: Staircase Comments: At the head of the staircase there is a permanent louvered vent which may have mechanical extraction</p>

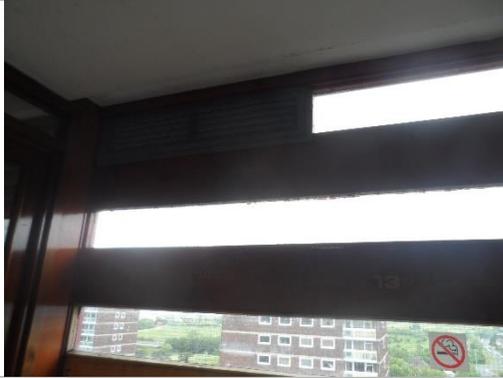
<p>Photo No 2 Reference point : D32 Location: Staircase Comments: At each third level in the staircase there are small vents to the glazed screen</p>

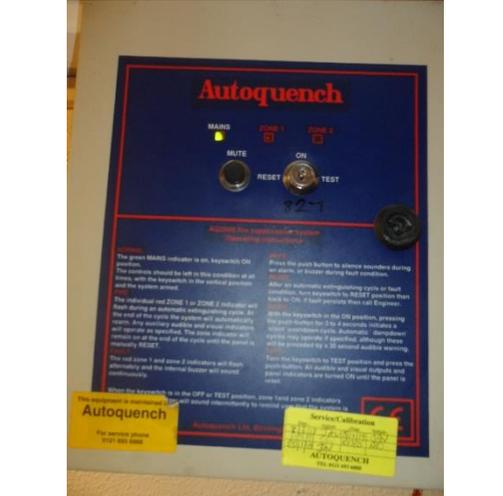
<p>Photo No 3 Reference point: F16 Location: Ground floor Comments: In the bin store there is an 'Autoquench' system installed using AQ2000 (water mist). There is a control panel in the lift lobby at ground floor.</p>

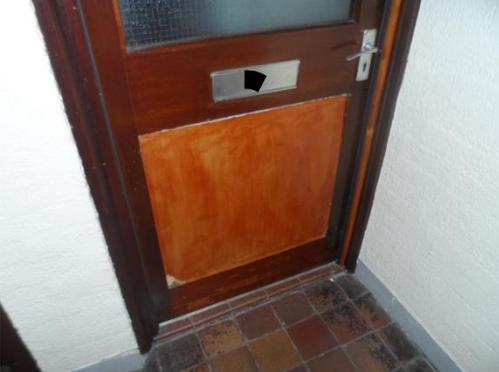
General Observations & Photographic Evidence	
<p>Photo No 4 Reference point: D32 Location: 1st floor Comments: The following doors are damaged and need repair: 1. 1st floor plywood panel to the lower part of the door</p>

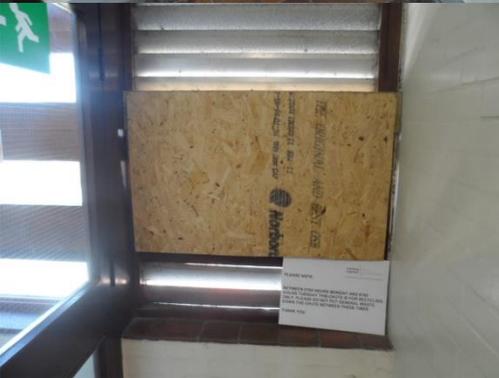
<p>Photo No 5 Action point: D36a Location: 14th floor Comments: The louvered vents in the bin chute lobby at 14th floor is blocked with a plywood barrier</p>

Hazard Ref No	Location	Hazard Description	Priority	Recommended Action	Action by date	Status	Comment
D34	Shed area	To prevent the unrestricted spread of fire and smoke, fire doors to cupboards, service ducts and risers, plant rooms and other higher risk areas that are not fitted with self-closure devices should be kept locked shut when not in use.	Low	The following fire doors were not locked shut: 1: The shed marked as unknown is not secured shut.	October 2017		
D35	Various	Lifts that do not ground upon actuation of the fire alarm should have signs indicating that they are not to be used during an evacuation displayed at the entrance to each lift car at each floor level.	Low	Lift signs are required at all floor levels.	October 2017		
D36a	14 th floor	Areas of open vents in the staircase and lobbies is provided to allow smoke and gasses to be vented to open air. The area of venting should all be free from obstructions	Medium	The louvered vents in the bin chute lobby at 14 th floor is blocked with a plywood barrier (Photo 5)	October 2017

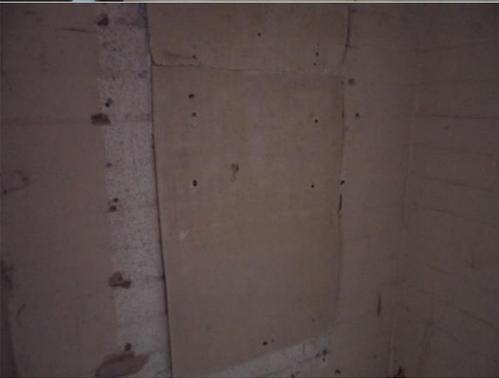
<p>Photo No 6 Action point: D27a Location: Electrics cupboard Comments: There is a panel covering a void outside of the ground floor electrics cupboard which is not secured fully to the wall.</p>

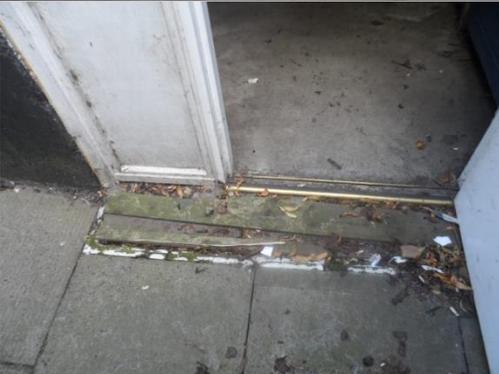
<p>Photo No 7 Action point: D2 Location: Outside of the emergency exit from the shed area Comments: Outside of the emergency exit from the shed area there is a gulley which has an uneven wooden covering which should be replaced.</p>

Hazard Ref No	Location	Hazard Description	Priority	Recommended Action	Action by date	Status	Comment
A17	Management	There no available records on site to indicate that the fixed electrical installation has been subject to a full 5 yearly test by a competent engineer.	Low	It should be ensured that the fixed electrical installation is subject to an appropriate testing and maintenance regime.	October 2017		
A24	Throughout	Mains electrics cables located in common escape routes should be secured to the structure using fixings that in the event of fire will not fail. This ensures live cables are not hanging down creating a hazard during fire fighting	Low	During refurbishment or when mains electrics are being worked on the fixings should be changed.	As work is ordered to electrics systems		
D2	Outside of the emergency exit from the shed area	Fire exit routes should be free from slip and trip hazards.	Medium	Outside of the emergency exit from the shed area there is a gully which has an uneven wooden covering which should be replaced. (Photo 7)	October 2017

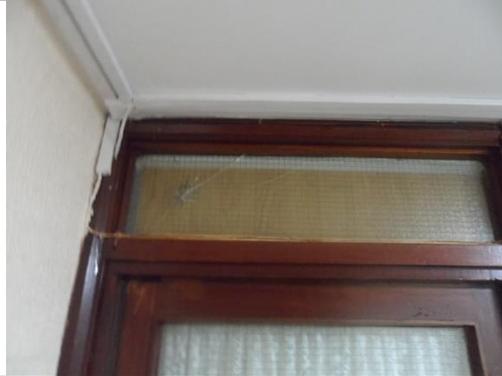
6th floor – the Georgian wired glass in the fanlight to flat is broken.

Hazard Ref No	Location	Hazard Description	Priority	Recommended Action	Action by date	Status	Comment
D32	Various	To prevent the unrestricted spread of fire and smoke, fire doors should be installed as per manufacturer's instructions and thenceforth maintained in good condition.	Medium	The following doors are damaged and need repair: 1: 1 st floor – flat – plywood panel to the lower part of the door (Photo 4)	October 2017		
D33	Various	Glazing installed in fire doors and partitions should achieve at least the same level of fire resistance as the door or partition in which it is sited.	Medium	Glazing within the following fire doors/partitions are damaged or do not appear to be fire resisting: 1: 6 th floor – the Georgian wired glass in the fanlight to flat is broken. (Photo 9)	October 2017
